Clinical Image

Iatrogenic Complete Ureteral Dissection after Retrograde Stenting: Imaging Features

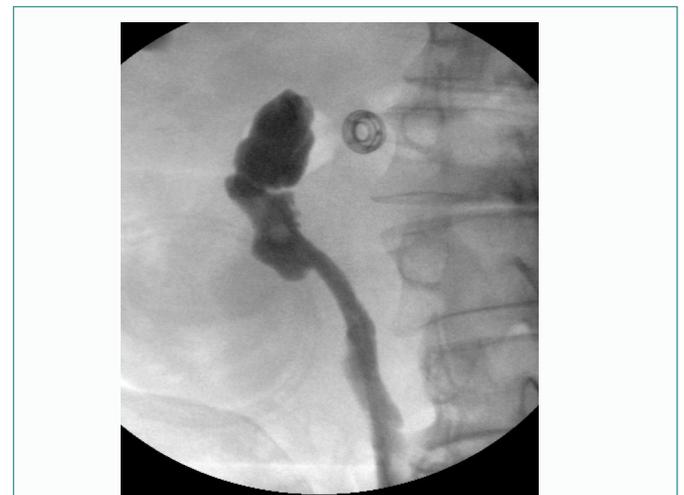
Figure 1: The retrograde pyelogram after stent placement showed a cavity with irregular parietal wall consistent with the false lumen creation along pelvis and ureter. Note the absence of visualization of the collecting system as further suspicion feature of ureteral dissection. Patient is in prone position.

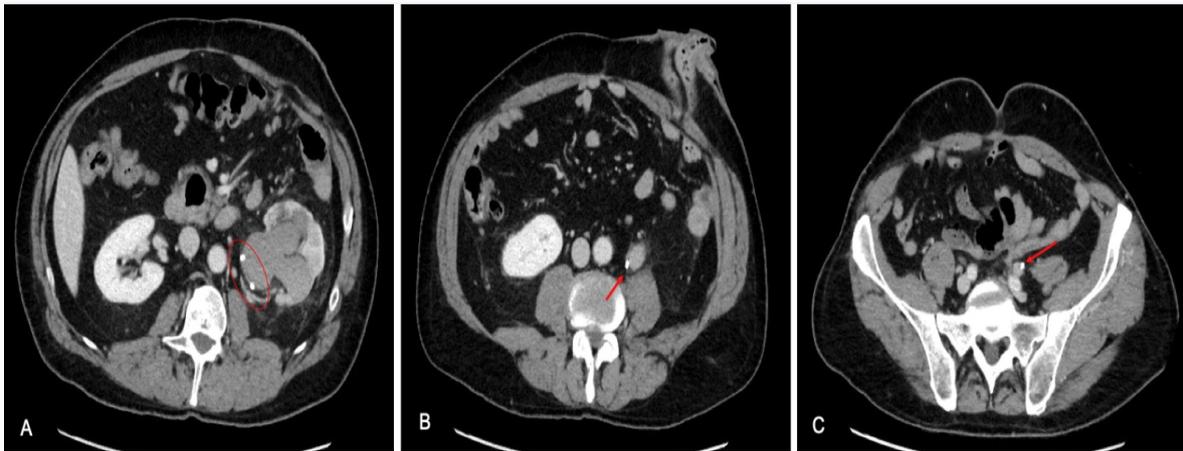
Figure 2: Axial venous contrast-enhanced CT scans at the pelvis (A), upper (B) and middle ureter (C) showed the stent (red circle in A and red arrows in B-C) not in the lumen. In A note the atrophic left kidney probably due to chronic obstruction hydronephrosis.

A 60-years-old man with history of rectal carcinoma treated with surgery and pelvic radiotherapy developed a left fibrotic ureteral stenosis which was treated with periodical stent replacements. The stent was regularly changed for a ten years period until the last time in which the patient was lost at the follow-up for three years. This lapse was caused by the pandemic outbreak which upset all the waiting lists. So, the patient came to our attention with fever and left flank pain likely induced by the stent obstruction. He underwent a fluoroscopy-guided retrograde double-J stent replacement with a following pyelography showing an apparent correct positioning of the proximal loop in the pelvis with also diffuse irregularity of the parietal wall interpreted as the renal collecting system, ureter and bladder reaction to the chronic presence of the foreign body (Figure 1). One day later, the patient presented with intense flank pain and hydronephrosis at Ultrasound (US) examination. So, he underwent abdominal contrast-enhanced Computed Tomography (CT) scan which confirmed the left hydronephrosis. Moreover, the left stent completely run into the ureteral wall thickness thus, a ureteral dissection was supposed (Figure 2). After a multidisciplinary briefing, the indication to percutaneous nephrostomy catheter placement was given. Access into the renal collecting system was gained with US and fluoroscopic guidance and antegrade pyelography relived the stent “outside” the opacified ureteral lumen confirming the malposition (Figure 3). Then, the stent was removed by cystoscopy and a new double-j stent was placed *via* the antegrade percutaneous access.

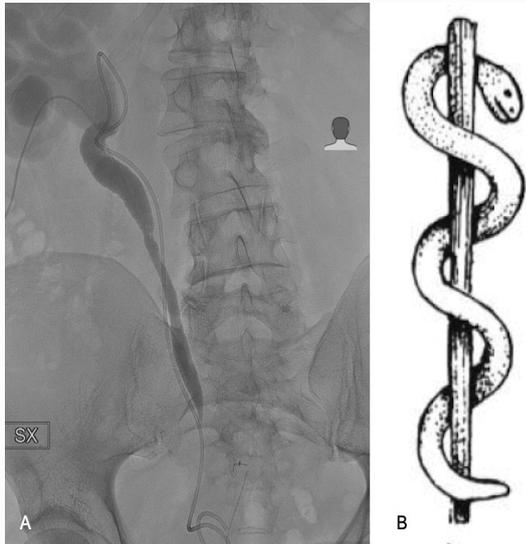
Figure 3: (A). The anterograde pyelogram after percutaneous nephrostomy allowed to opacified correctly the excretory system and to confirm that the stent was located externally the lumen. Patient is in prone position. (B). Rod of Asclepius symbol consisting of a serpent coiled around a rod.

This case demonstrates how the incidence of periprocedural complications increases as longer the stent remains in place. A prolonged indwelling stent times, in fact increases the risk of urinary tract infection, encrustation with obstruction, stent fracture, ureteral erosion or fistulation and malposition after exchange as in our case [1,2]. The ureteral dissection is a rare condition that, at the urography CT scan or antegrade pyelography, could show imaging findings of double lumen and/or contrast extravasation if the injured mucosa advance towards the full-thickness ureteral wall rupture [3]. In our case, the tear of the inner ureteral layer was probably at the distal end of the ureter and the false lumen was observed only when contrast was injected retrograde or inside it. To our knowledge, it is the first time that a complete ureteral dissection is documented with the particular feature at pyelography of a snake-like catheter twisted around the ureteral lumen and that we labelled as “Asclepius' rod sign”.
