Case Report

Osteochondral Fracture-Dislocation of the Humeral Head in Adolescent Patient: Open Reduction and Internal Fixation with Low Profile Compression Screws

David A Quinzi*, Jason Lipof and John T Gorczyca

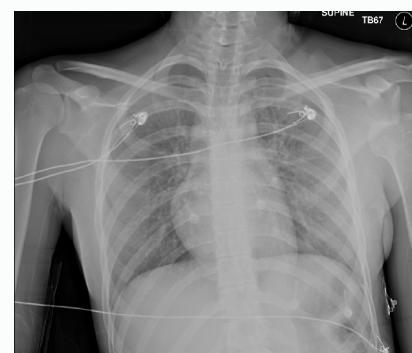
Figure 1A: AP Chest radiograph upon arrival to Trauma Bay reveals left glenohumeral dislocation with defect in humeral head.

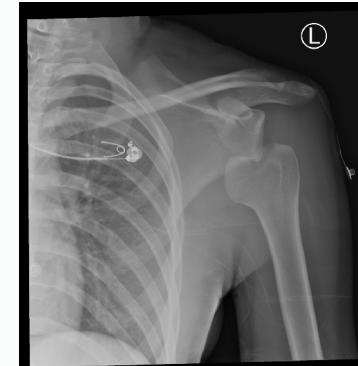
Figure 1B: AP radiograph of the left shoulder prior to manipulation.

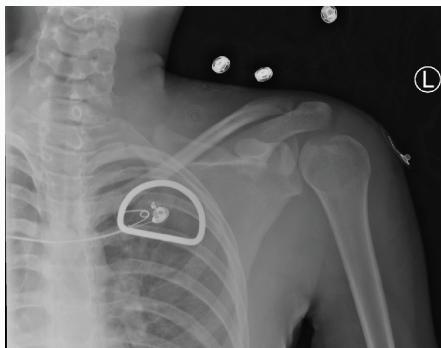
Figure 2A: AP radiograph of left shoulder after reduction attempt depicts entrapped intraarticular osteochondral fragment.

A closed reduction of the left shoulder under conscious sedation was performed using traction and internal rotation. A palpable clunk was appreciated, after which the patient remained neurovascularly intact and was able to contract her deltoid muscle. Post-reduction imaging demonstrated a non concentric reduction with a large entrapped osteochondral fragment within the glenohumeral joint (Figure 2A and B). A Computed Tomography (CT) scan was obtained for further characterization of the injury (Figure 3). After a discussion

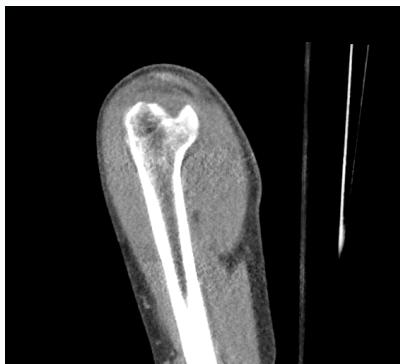
Figure 3C: Sagittal CT reconstruction depicts defect in the superior humeral head articular surface.

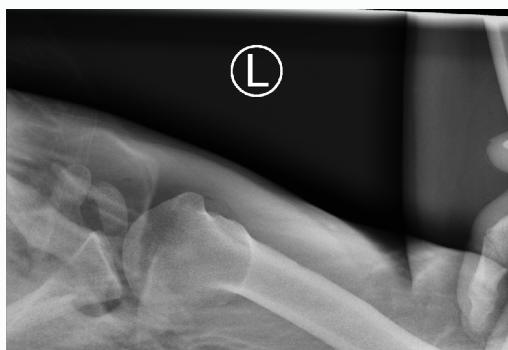
Figure 2B: Axillary Lateral View radiograph after reduction attempt reveals intraarticular osteochondral fragment.

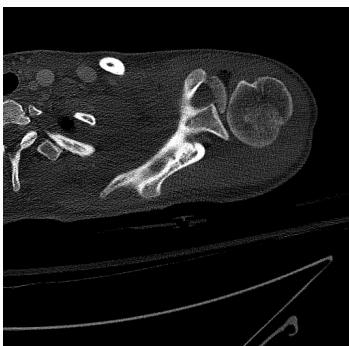
Figure 3A: Axial cut of CT scan left shoulder with entrapped osteochondral fragment.

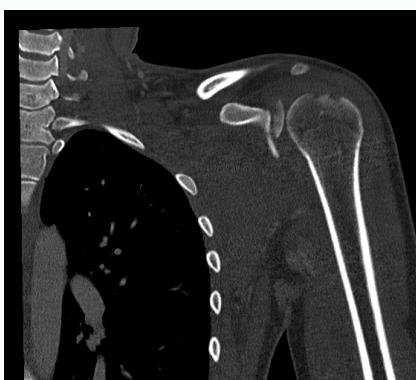
Figure 3B: Coronal reconstruction of CT scan Left shoulder shows osteochondral fragment that appears to be rotated 180° in the axial plane.

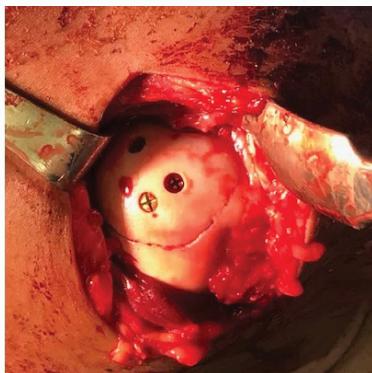
Figure 4: Intraoperative photograph shows final reduction of osteochondral fragment with screws countersunk below articular cartilage of humeral head.

After confirming appropriate reduction of the fragment, three 2.4 mm lag screws were inserted and countersunk beneath the articular cartilage into the subchondral bone (Figure 4). These provided excellent compression and an anatomic reduction as confirmed on final intraoperative fluoroscopy (Figure 5). The subscapularis tendon was repaired to its insertion on the lesser tuberosity using #2 non absorbable suture placed through drill holes. The biceps sheath and rotator interval were closed with 1-0 absorbable suture, followed by closure of the deltopectoral interval. 2-0 absorbable suture was utilized for the thin subcutaneous layer and the skin was closed with a 3-0 absorbable monofilament suture in running subcuticular fashion. She was then awakened from anesthesia without complication.

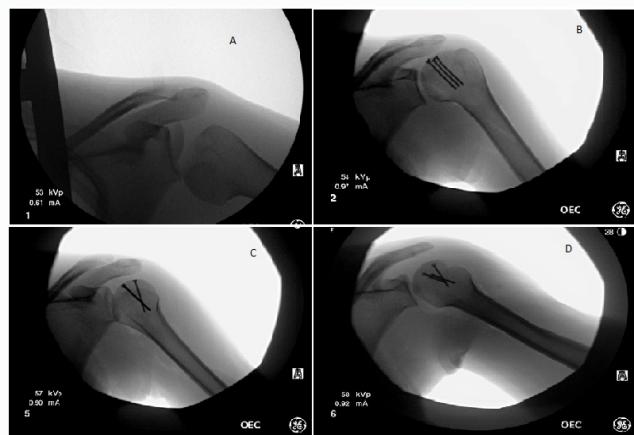
Figure 5: Intraoperative fluoroscopic images detail displaced fragment (a) and anatomic reduction and stabilization with three screws (b-d). Noted Hill-Sachs defect.

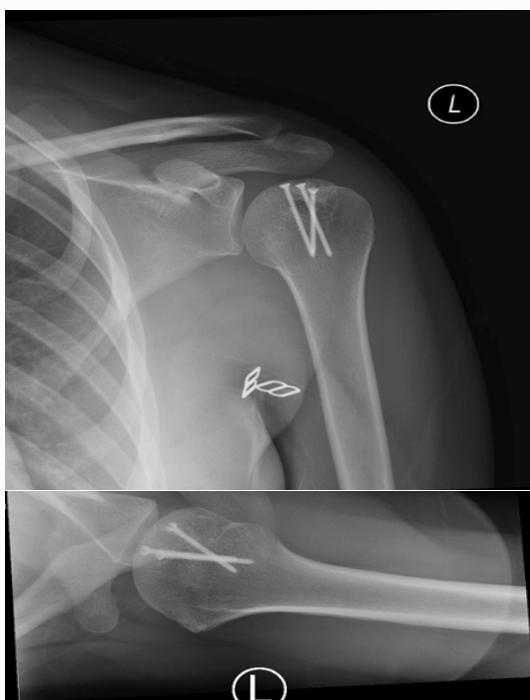
Figure 6: 18 month follow-up AP and axillary lateral radiographs demonstrate healed fracture, congruent articular surface, good incorporation of the osteochondral fragment, and no sign of a vascular lesion.

and doing well. She reports being back to her pre-injury activities and work without issue. She reported occasional discomfort in her shoulder after she performed extensive activity, which was relieved by anti-inflammatory medication when needed. On examination, she had 180° forward flexion. With the shoulder in neutral, she had external rotation to 55 degrees (same as contralateral). With the arm abducted at 90 degrees she has a 10-degree deficit of external rotation as compared to the contralateral shoulder. Radiographs demonstrated a healed fracture, a congruent articular surface, good position of the screws, incorporation of the osteochondral fragment, and no evidence of osteonecrosis (Figure 6).
