Case Report

Esthetic Rehabilitation of a Discolored Maxillary Canine Tooth with a Porcelain Laminate Veneer

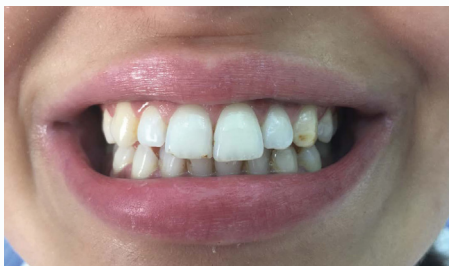
Figure 1: Discolorations at left maxillary canine tooth.

discoloration at her maxillary left canine tooth (Figure 1). On the clinical examination of the patient, fluorosis related discolorations were observed at the labial medium 2/3 and the incisal part of her left maxillary canine tooth. Radiographic and clinical examination did not reveal any caries or periapical pathological condition. Occlusion was in a class 1 relationship, oral hygiene was good and the gingival tissues were healthy. As a result of the examinations, all appropriate treatment options for this case were described to the patient. CAD/CAM manufactured and individualized by cut-back method porcelain laminate veneer was accepted by the patient as a treatment option.

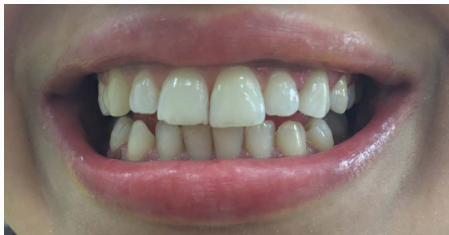
Figure 2: Clinical view after cementation process.

Porcelain laminate veneer was manufactured by CAD/CAM method (Sirona X5 Scanner - SironaInlab 3D Software - Sirona MCX5 Milling Machine, Sirona Dental Systems, Germany; Vitablocs Triluxe Color 1M2, Vita Zahnfabrik, Bad Sackingen, Germany). Individualizations were made in cut-back technique to achieve the proper aesthetic result (Vita VM 9 Porcelain, Vita Zahnfabrik, Bad Sackingen, Germany). The coherence and the fit of the laminate veneer were verified both individually and collectively on the prepared tooth. The patient was satisfied with the form, shade and adaptation of the restoration. Final cementation was done with dual-cure resin cement (Variolink Esthetic Neutral, Ivoclar-Vivadent, Schaan, and Lichtenstein) (Figure 2). The occlusion and contact correction with final polishing and finishing process was applied after 24 hrs of cementation. Post-operative photos were taken and a night guard oral appliance was performed in order to prevent any trauma on the veneer caused by the Para-functional habits (Figure

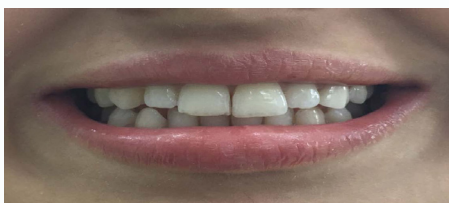
Figure 3: The occlusion and contact correction with final polishing and finishing process was applied after 24 hours of cementation.

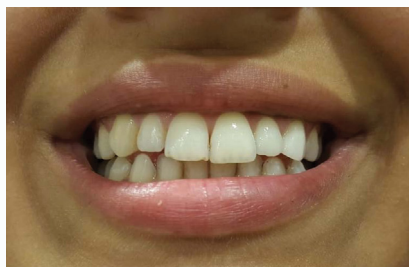
3). One year post-operative evaluation did not reveal any fracture or discoloration of the veneer restoration (Figure 4). Patient was pleased with the conformity and esthetics of the restoration.

Figure 4: One year post-operative view.
